MTL TR 90-53

FAILURE ANALYSIS OF THE LAU-7/A LAUNCHER RETENTION BAND ASSEMBLY

VICTOR K. CHAMPAGNE, Jr. and GARY WECHSLER
MATERIALS TESTING AND EVALUATION BRANCH

November 1990

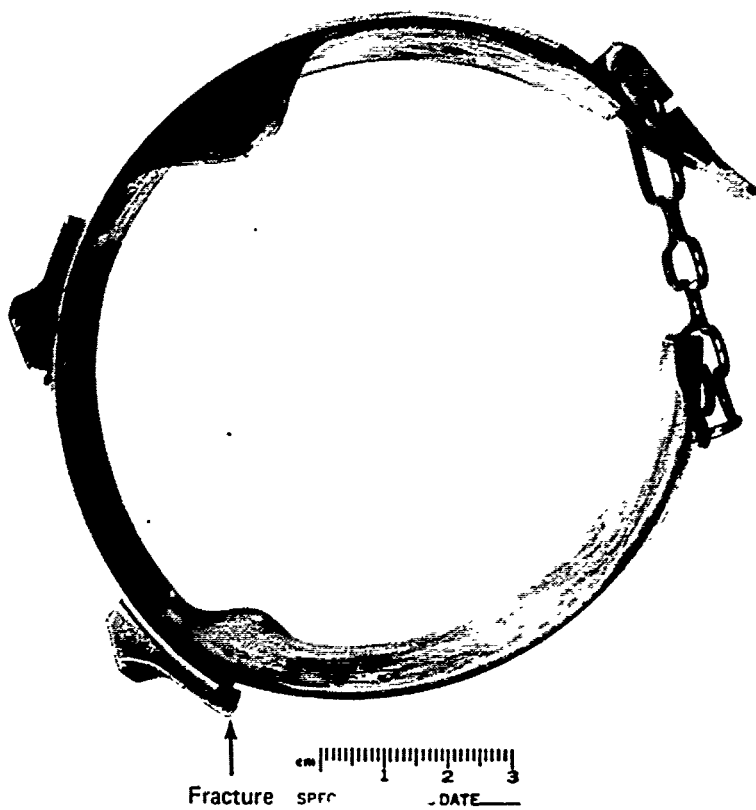
Figure 6 shows the retention band assembly in the as-received condition. The failure occurred at the spot-welded regions where the base, P/N 58A164C528 was joined to the band, P/N 58A164B532 (refer to lower left-hand corner of the macrograph). The inside liner which was bonded to the 301 stainless steel band experienced delamination in several places, including the area across the fracture zone. The significance of this finding was that the interface between the two parts caused by the debonding, could entrap moisture and/or an aggressive species which may initiate crevice corrosion. Another ideal situation for crevice damage was observed between the 17-4 PH stainless steel base and the band. Since spot welds were utilized to connect the parts together, the perimeter of the base was not adequately sealed off from the environment. This design provided an entrance for corrosives and a suitable haven for crevice corrosion to occur between the mating surfaces. Figure 7 reveals the fractured region from a different angle. It can be easily distinguished from this view that the failure occurred across the three spot-welds. The weld nuggets remained intact with the base while the band was completely severed from the welded assembly. The external surface of the band appeared to be free of any significant amounts of general corrosion or pitting, but

Figure 6. Shows the retention band assembly in the as-received condition.

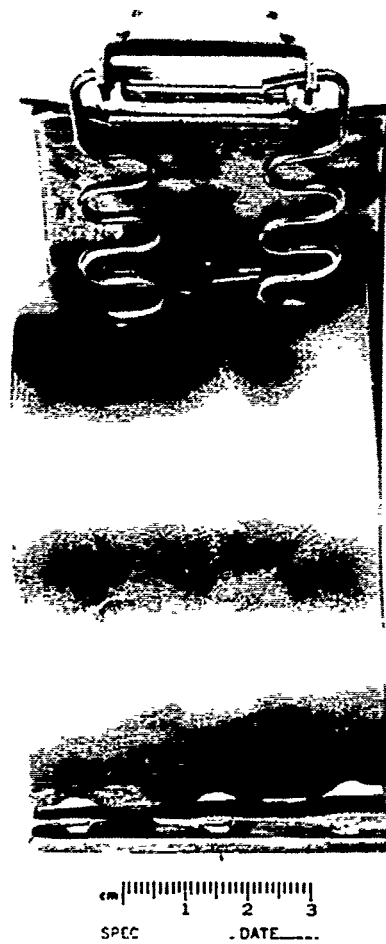
Figure 7. Reveals the fracture which occurred across three spot welds used to attach the retention base to the band.

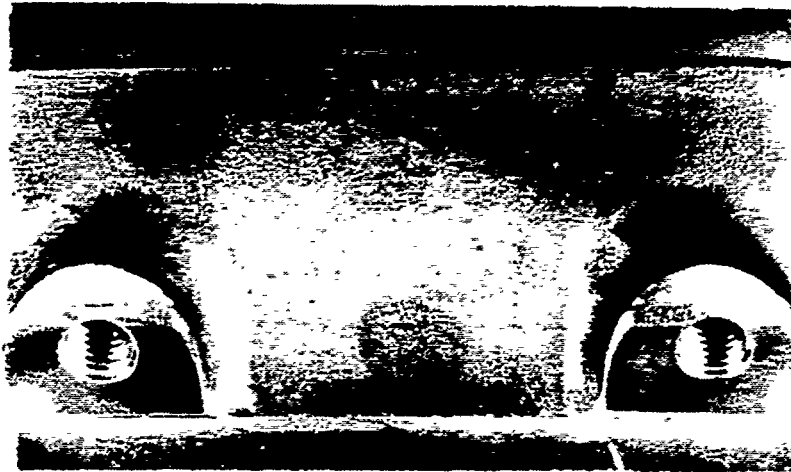
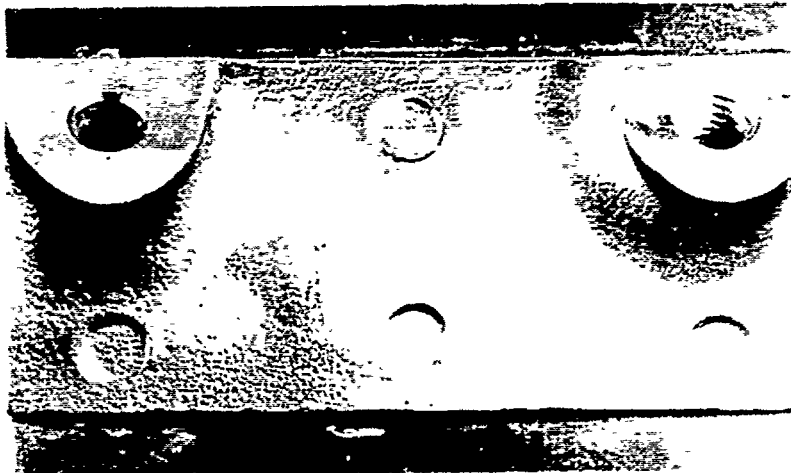
Examination of additional randomly selected retention band assemblies verified that the spot welding procedure was not adequately controlled. Figures 11 through 13 represent the spot welds of three additional components. The welded regions of Figures 11 and 13 are much less pronounced than the deep impressions contained in Figure 12. These cavities can act as stress concentration areas where a fatigue crack could initiate.

Figures 11 through 13. Optical photographs showing spot welded regions of three separate retention bands. Note that the surface depressions occur randomly, indicative of a welding proces. that had not been adequately controlled. Mag. 2.2X

1. The resistance welding process must be controlled to insure uniform, high quality spot welds. The important variables involved include, but are not limited to, the following:

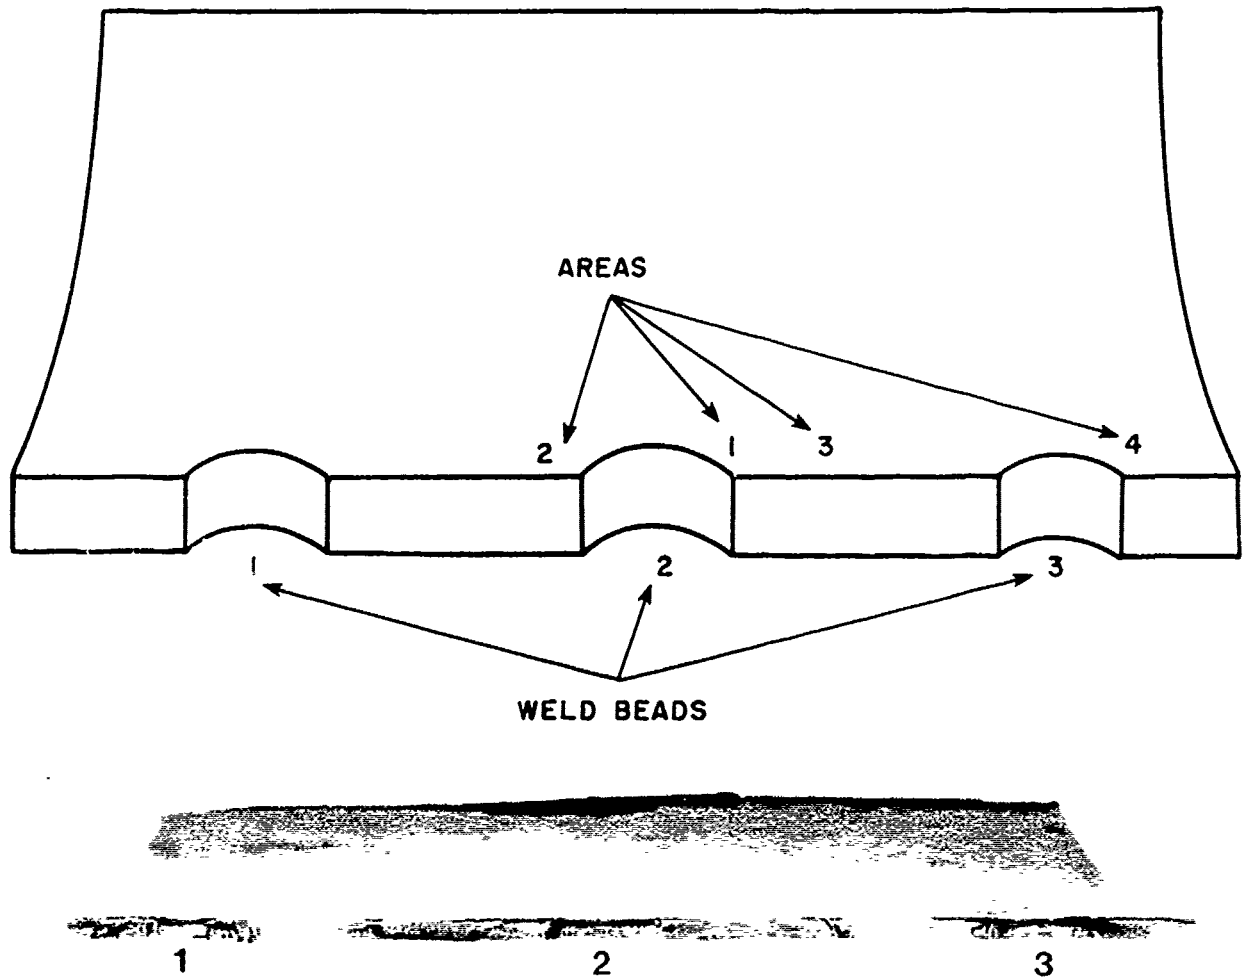
The area of the retention band that contained the fracture was sectioned and removed from the assembly. Figure 14 shows the locations where the three weld beads had ruptured. These areas have been appropriately identified for future reference. Macroscopic examination under low magnification was utilized to determine the crack origin and to correlate fracture surface characteristics with the overall geometrical configuration of the component and the loading conditions. Figure 15 contains the fracture surface to the right of the weld bead no. 1 (refer to Figure 14 for exact location). The most important observation was the existence of beach marks which can be seen emanating from the bottom left-hand corner of the weld bead and resemble the ripples or waves that form, such as when a stone is dropped into a still body of water. Beach marks, often referred to as clamshell marks, may occur from oxidation of the fracture surfaces during periods of crack arrest from intermittent service and are associated with fatigue failures. They could also be the result of changes in loading or frequency.

Figure 14. Shows the location of the failure where the three weld beads had ruptured. Mag. 3X

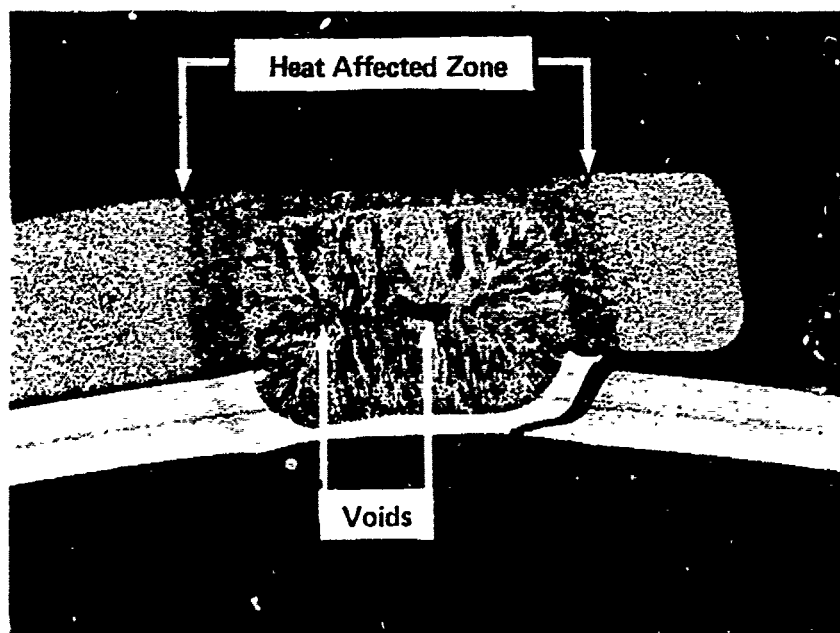
A cross section of the failure site located at weld bead no. 2 was taken and prepared for metallographic examination. The sample was etched utilizing a solution of 97% HCl and 3% HNO₃ with the addition of one half gram of CuCl₂. The resulting microstructure of the spot-welded assembly is revealed in Figure 18. The thin component is the 301 stainless steel band while the bottom part is the 17-4 PH stainless steel base. The failure occurred across the HAZ of the band at the corner of the depression made by the spot-welding electrode. Deeper cavities can be seen beneath the weld nugget and can act as stress raisers in the material. The HAZ is easily recognized at the areas which have etched darker and are characterized as the two vertical bands on either side of the weld bead. The weld nugget itself exhibits a typical dendritic structure representative of an as-cast material. Two voids can be observed near the center of the weld bead and may have been caused by entrapped gas or shrinkage.

Figure 18. Reveals the microstructure of the failed spot-welded assembly.
Note the failure occurred within the HAZ. Mag. 10X

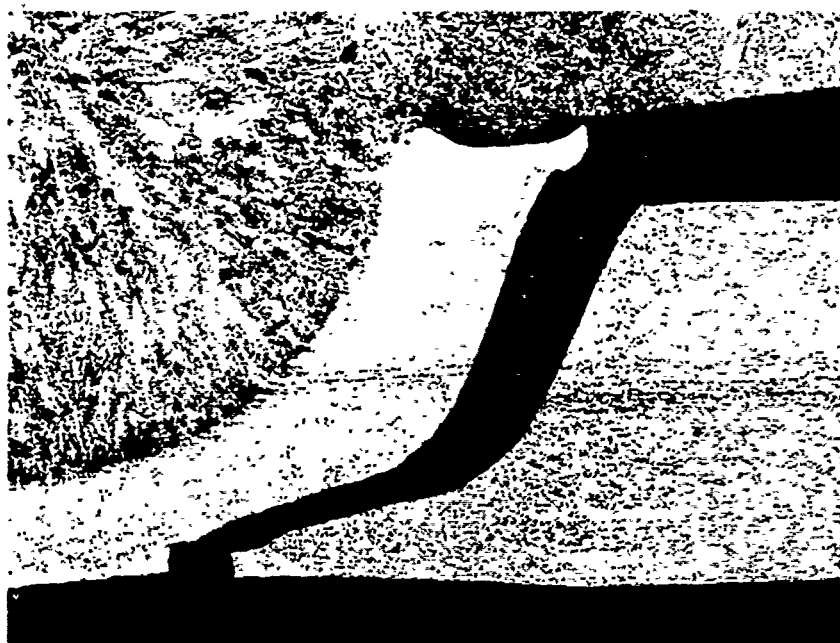
Figure 19 shows the failure site at higher magnification. The slender bands that run horizontally across the 301 stainless steel have preferentially etched darker because of prior cold working which occurred during primary material processing. The center grains have been compressed from external rolling forces forming flow lines. Figure 20 contains the microstructure outside of the HAZ of the 301 stainless steel band, while Figure 21 reveals the structure within the HAZ. The flow lines are much more discernable at these magnifications. Recrystallization has taken place within the HAZ which is signified by a smaller equiaxed grain size.

Figure 19. Higher magnification of the failure region showing flow lines at the center of the band. Mag. 50X

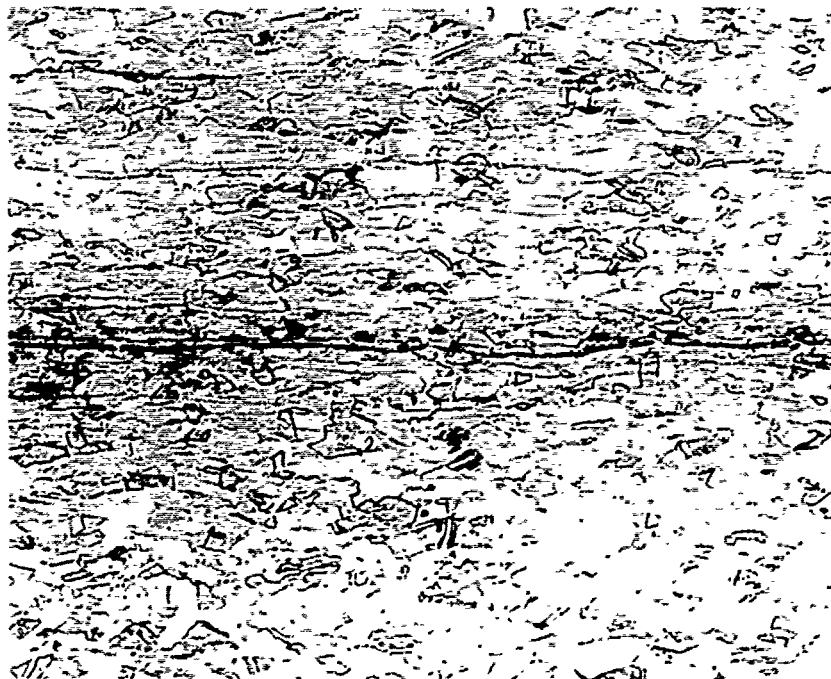
Figure 20. Microstructure of the 301 stainless steel band outside of the HAZ. Mag. 200X

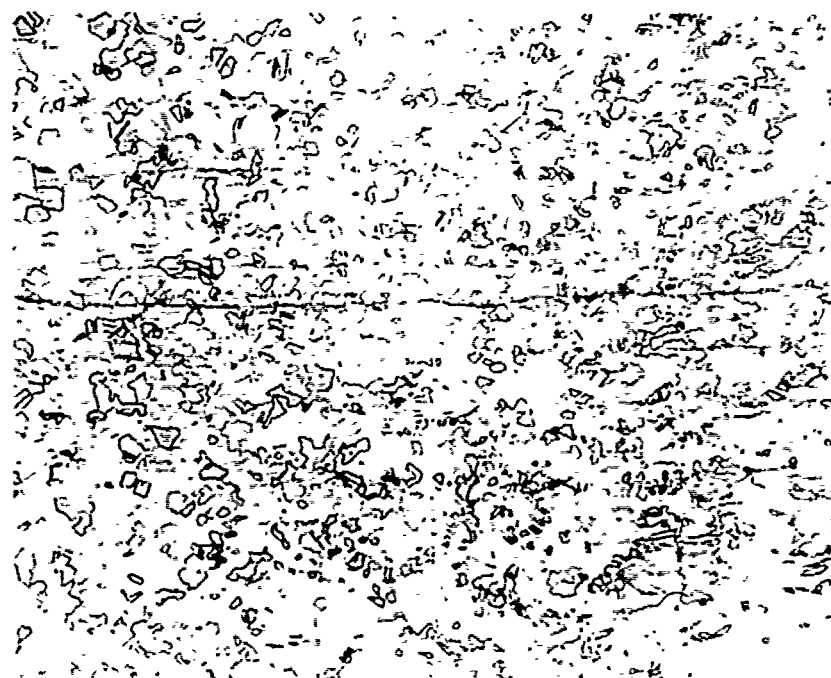
Figure 21. Microstructure of the band within the HAZ showing evidence of recrystallization. Mag. 200X

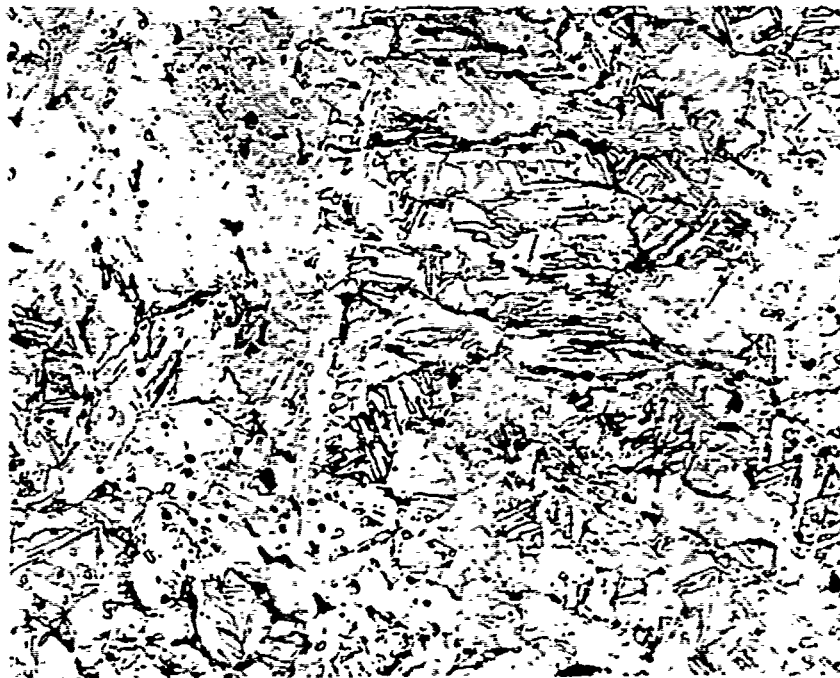
The matrix was clean with no signs of unusual microstructural features or large defects. There was no evidence of excessive carbide formation within the material. The structure of the retention base shown in Figure 22 is predominantly tempered martensite with islands of ferrite, while that within the HAZ is characterized by a refined martensitic structure as contained in Figure 23. Both areas also contain minimal amounts of untempered martensite.

Figure 22. Contains the structure of the 17-4 pH stainless steel base outside of the HAZ. Mag. 200X

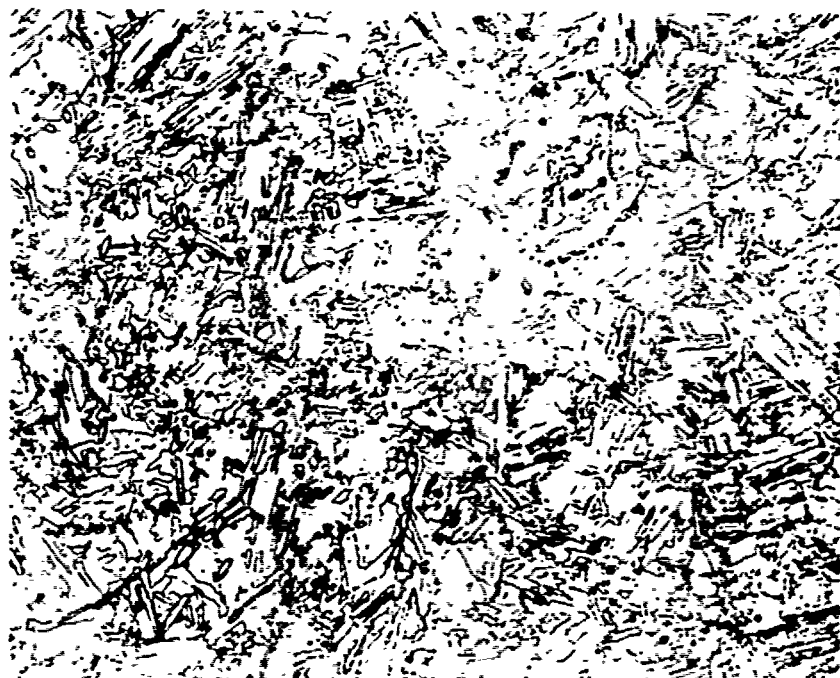
Figure 23. Shows the microstructure of the base within the HAZ which was predominantly martensitic with islands of ferrite. Mag. 200X

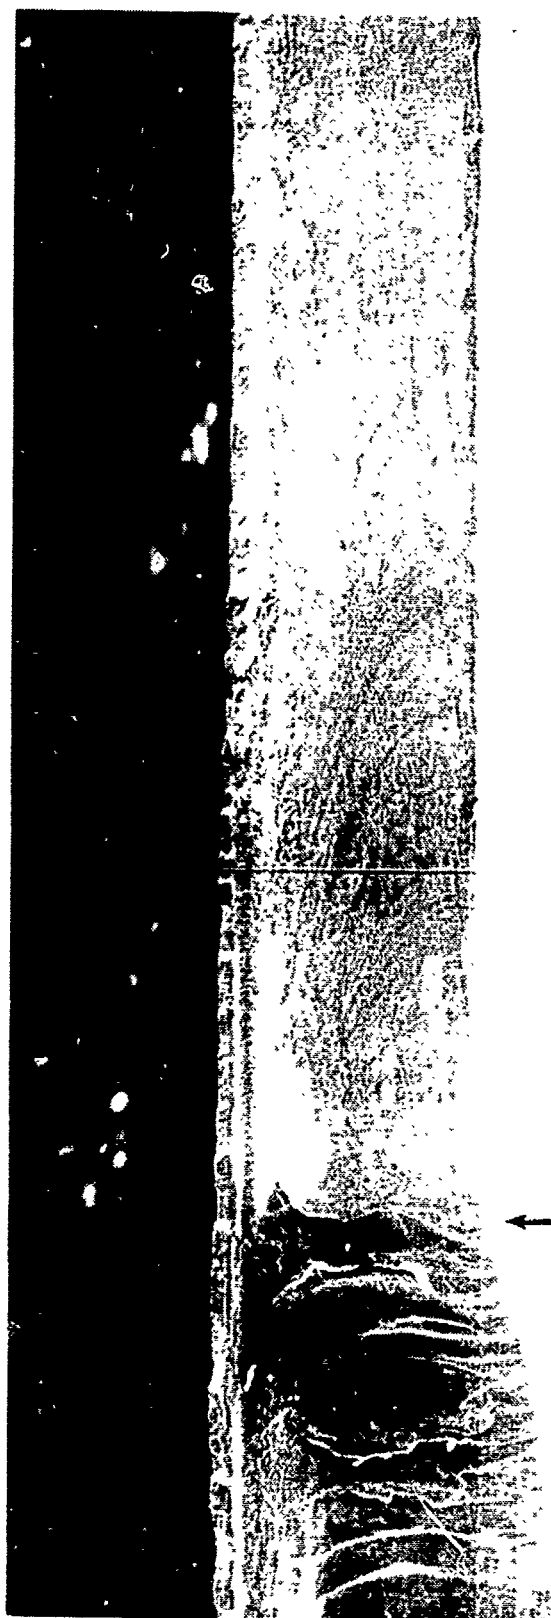
The fracture faces of the retention band were examined at a higher magnification utilizing the scanning electron microscope (SEM) in order to identify the failure mode in each of the three weld bead areas. Figure 24 shows the fracture surface within area 1 of weld bead no. 2 (identified previously on Figure 14). Well-defined beach marks are clearly distinguishable on the fractograph. The arrow points to the possible origin of the fatigue crack which is the common point where the beach marks converge. The surface near the crack nucleation site was relatively smooth and flat faced. Closer examination of the crack initiation site did not reveal any evidence of an inclusion or a surface defect, such as a corrosion pit.

Figure 24. SEM photograph showing the fracture surface within area 1 (identified previously on Figure 14). Mag. 50X

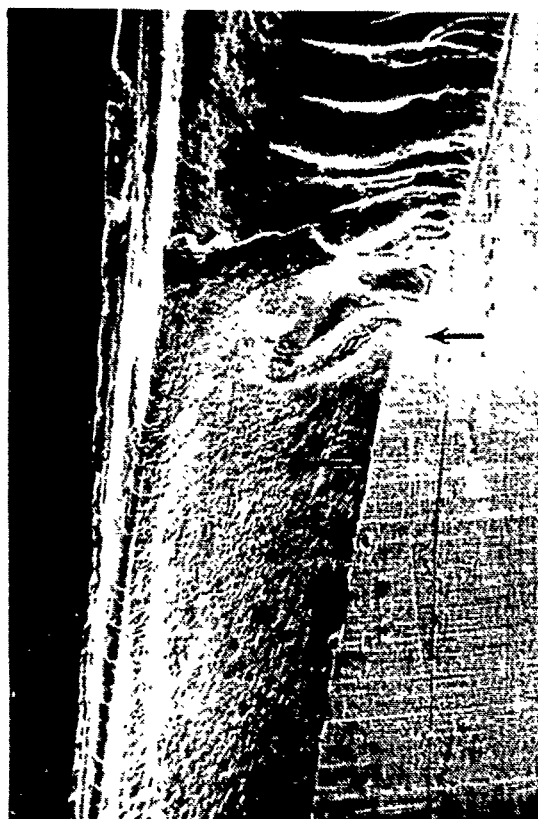
Figure 25 represents area 2 located near the same weld bead approximately 180° away from area 1. The beach marks observed in this region extend outward in an opposing direction to those contained in Figure 24. Another notable feature which was observed to the right of the crack origin (designated by the arrow) was parallel steps extending vertically across the thickness of the weld bead. These same markings were also found to the left of the crack initiation site contained in Figure 24 and are shown at higher magnification in Figure 26. These macroscopic patterns were the result of an advancing crack front which expanded across different planes.

Figure 25. SEM photograph of area 2 located near weld bead no. 2 showing beach marks. Mag. 50X

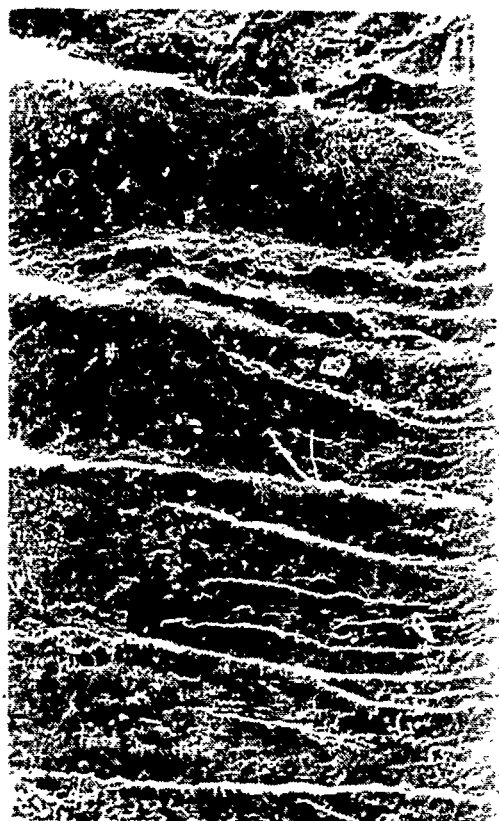
Figure 26. SEM micrograph revealing fracture patterns left behind by the advancing crack front. Mag. 100X

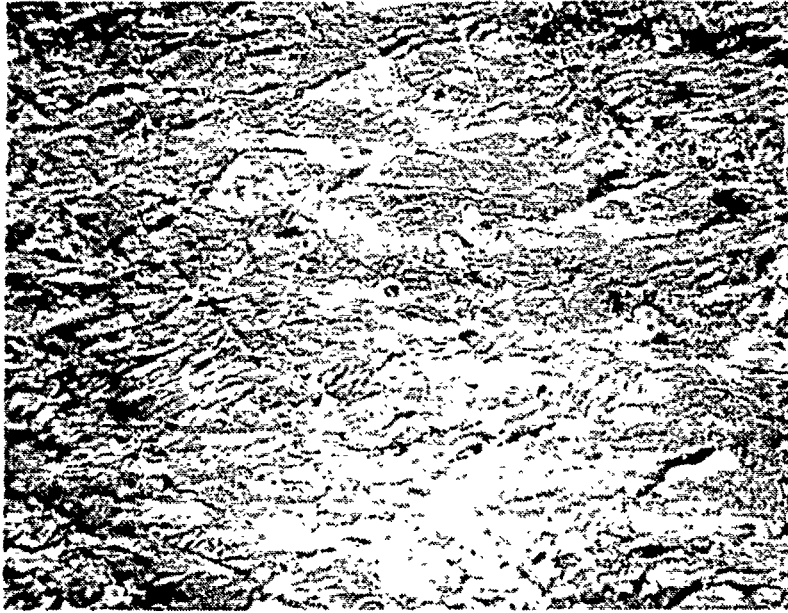
Figure 27 verifies that the fracture mechanism near the crack origin was transgranular in nature, where crack growth proceeded along crystallographic planes. Further examination of

Figure 27. Confirms that the fracture mode was transgranular near the crack origin. Mag. 1KX

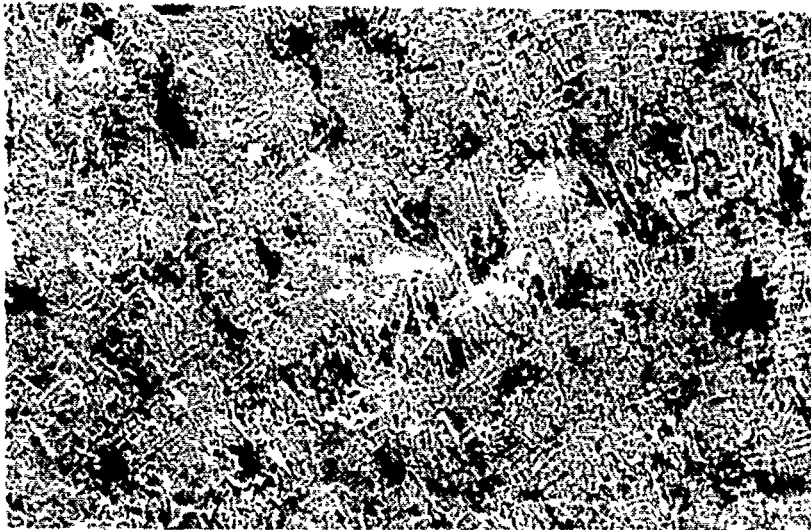
Figure 29. SEM fractograph verifying the existence of fatigue striations. Mag. 500X

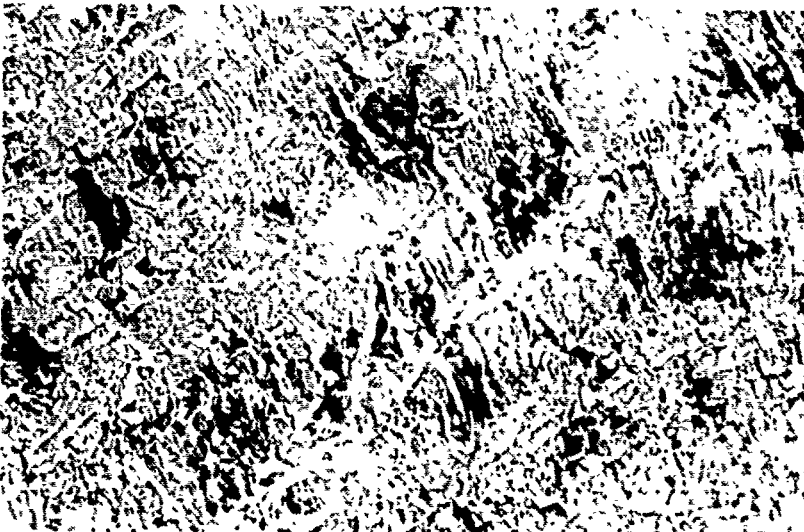
Figure 30. Higher magnification of striations contained in Figure 24. Mag. 1KX

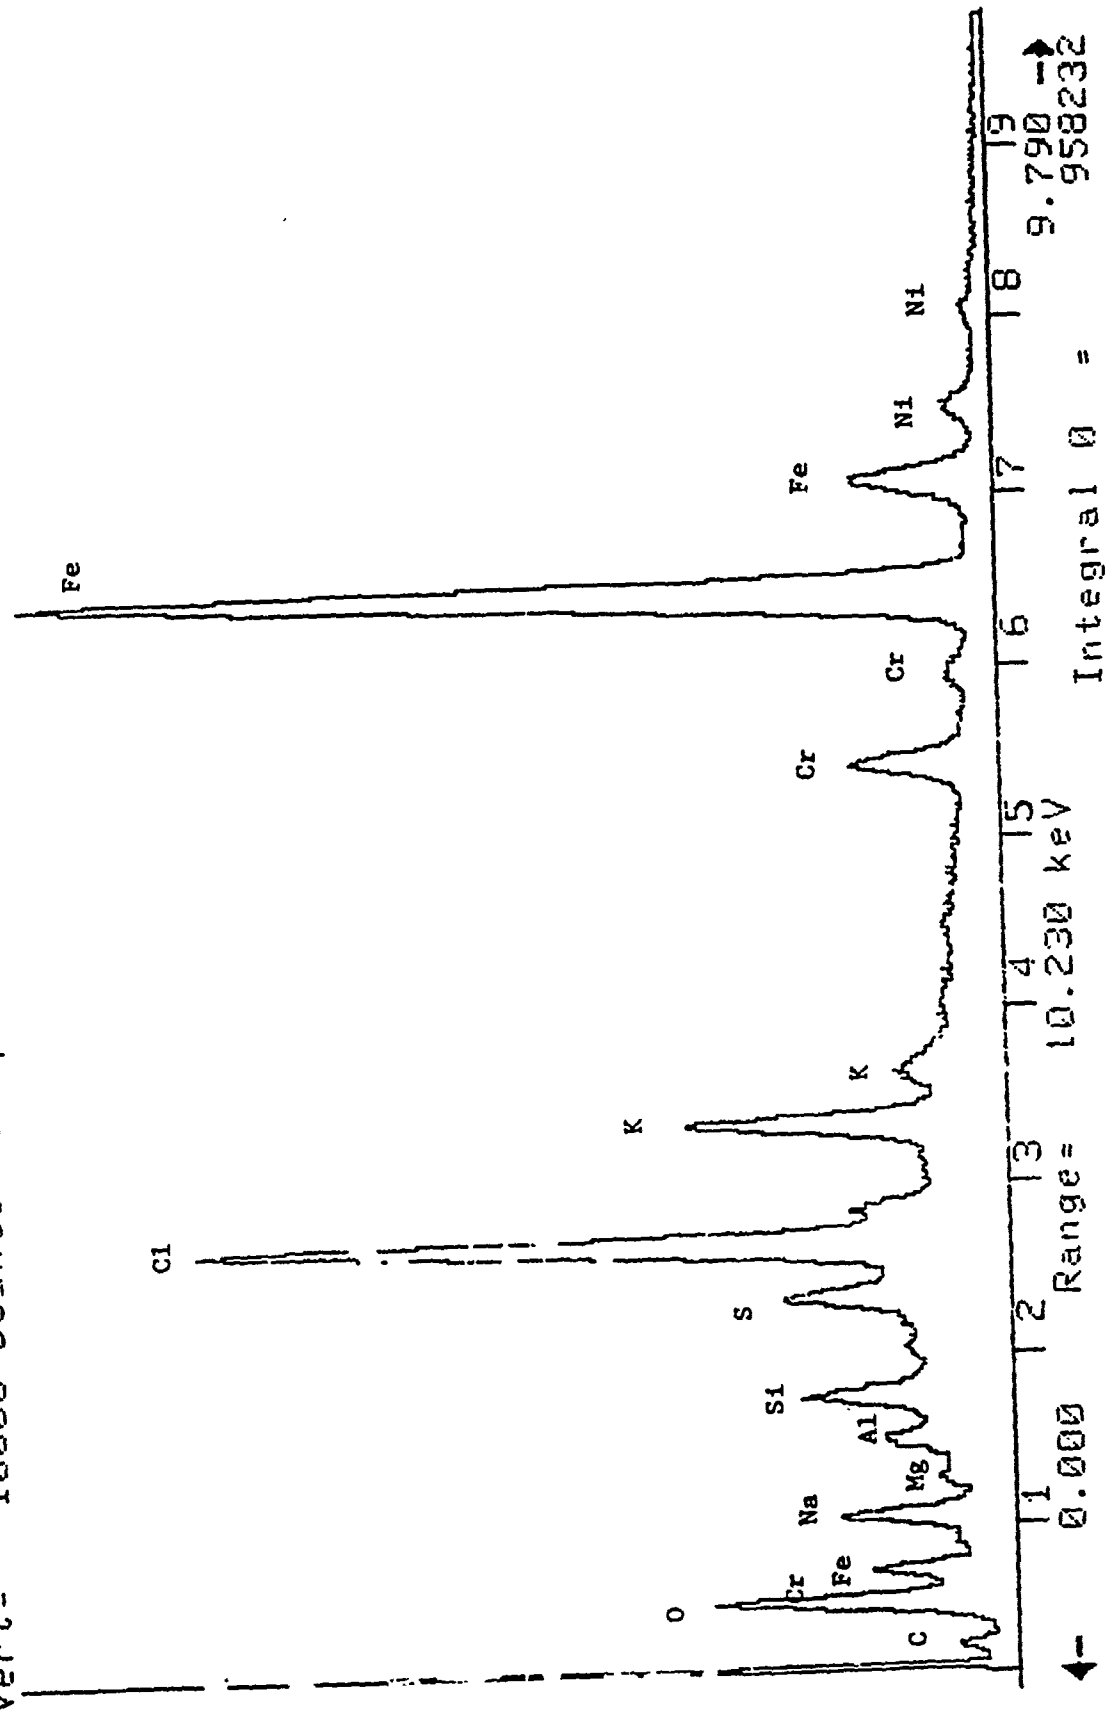
Figure 32. EDS spectra of dark corrosion spots within the fatigue region.

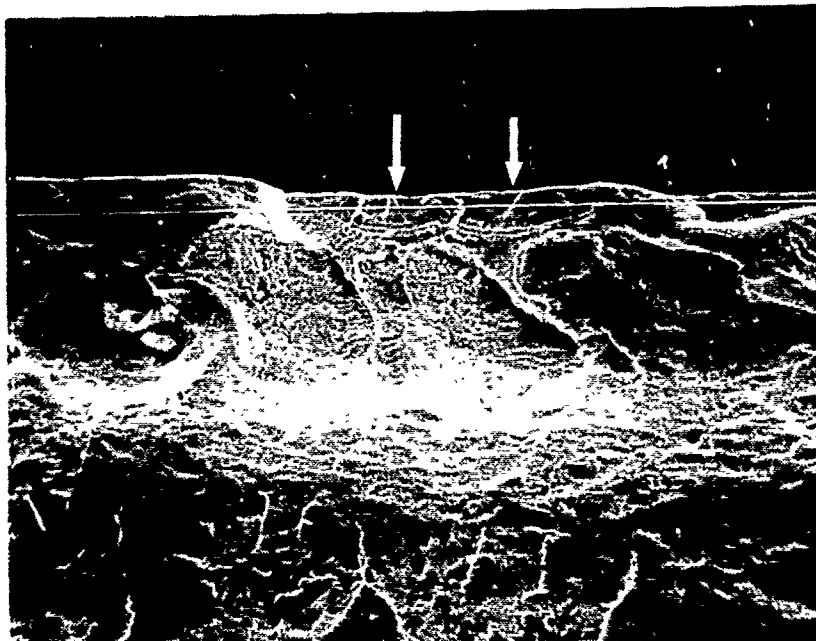
When examining the surface edge of area 3, positioned between weld beads no. 2 and no. 3, multiple cracks were observed side by side originating from the surface as shown in Figure 33. Multiple crack sites are associated with corrosion fatigue but there was no evidence of corrosion pitting and the crack origin was clearly visible. Often the crack initiation site of a corrosion fatigue fracture is indistinct because the compression portion of each stress cycle has forced corroded mating surfaces together leaving behind a irreconcilable fracture surface. Figures 34 and 35 are SEM fractographs showing secondary cracks which were observed within the HAZ of all the weld beads. Corrosion fatigue failures may display cracks or fissures perpendicular to the primary fatigue crack. These secondary fractures were confined only to the HAZ of the weld beads. Metallographic specimens sectioned from areas adjacent to and beyond the HAZ and further fractographic examination within similar regions did not reveal further signs of cracking. This evidence suggests that the stresses induced into the component during spot welding caused these fractures which may have initiated at carbides.

Figure 33. SEM fractograph of area 3 where multiple crack sites were found. Mag. 500X

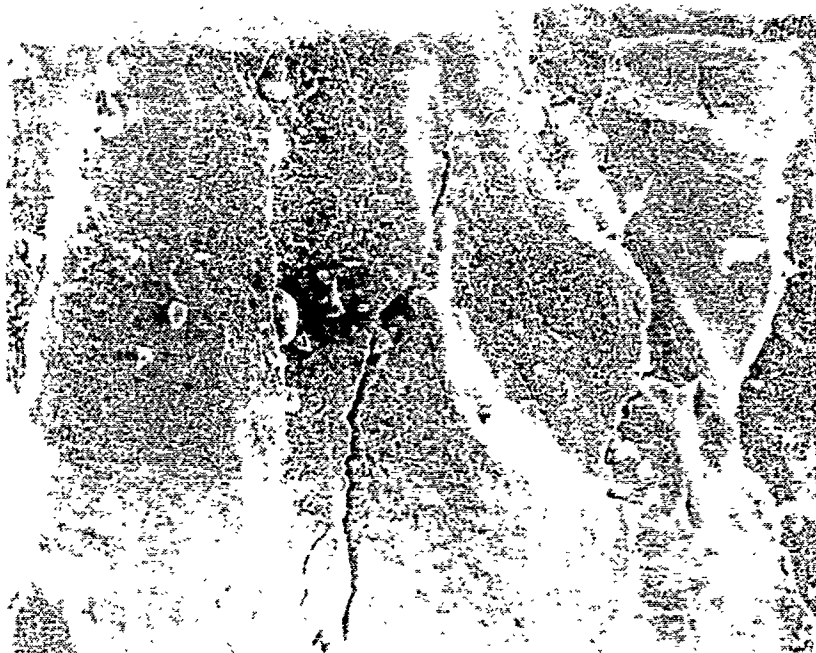
Figure 34. SEM micrograph showing secondary crack
within the weld beads. Mag. 400X

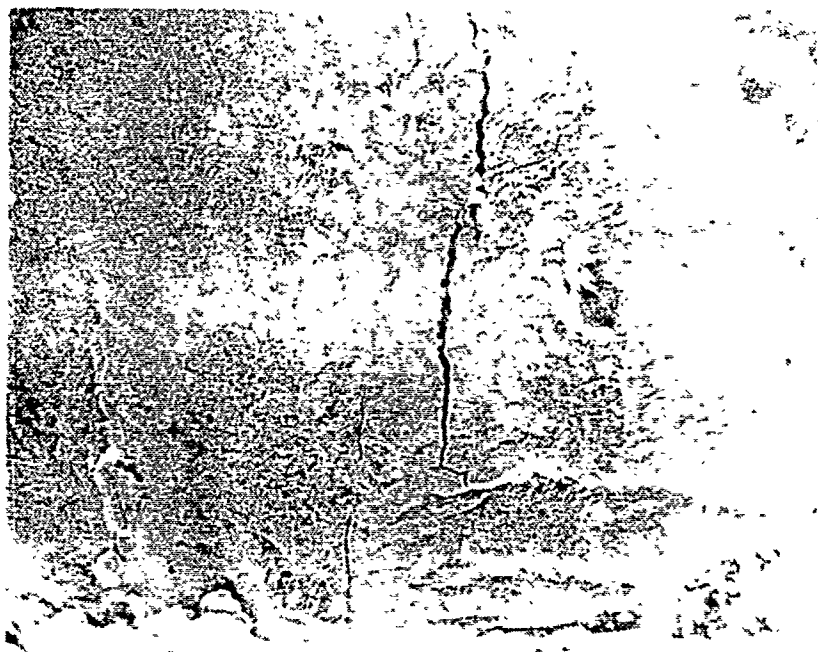
Figure 35. SEM micrograph showing secondary crack
within the weld bead. Mag. 500X

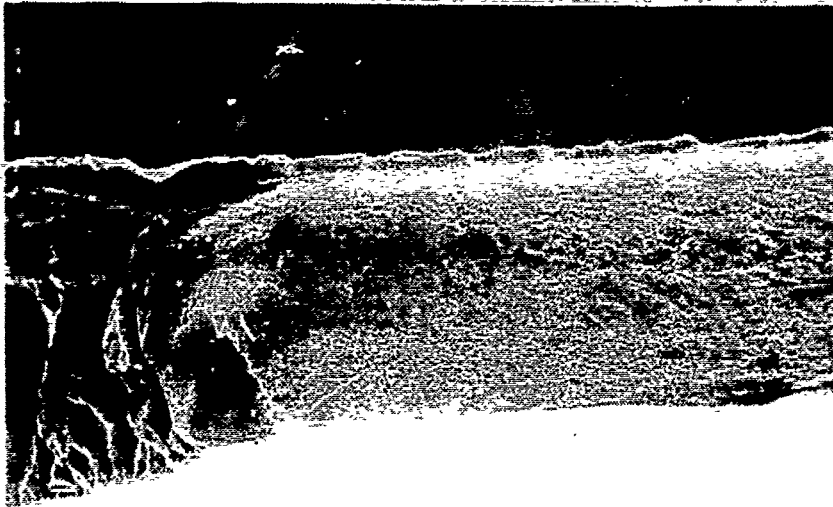
The failure mechanism and surface morphology of the remaining weld beads were consistent with those of weld bead no. 2 with the exception of the appearance of the beach marks and the size of the final fast fracture zone. Figure 36 shows the beach marks found in area 4 of weld bead no. 3 which were significantly fainter and less pronounced. In addition, the fast fracture zone of weld beads no. 1 and no. 3 were larger. The surface topography within the fast fracture regions were expected to display evidence of dimples which are indicative of

Figure 36. SEM fractograph of the faint beach marks observed in area 4 of weld bead no. 3. Mag. 50X
